07/30/71 Pan American World Airways, Inc.

Report Number	NTSB-AAR-72-17
Catalog Number	PB-.211 457
Report Title	Pan American World Airways, Inc., Boeing 747, N747PA, Flight 845, San Francisco, California, July 30, 1971
Report Date	May 24, 1972
Organization Name	Bureau of Aviation Safety National Transportation Safety Board Washington, D. C. 20591
Sponsor Name	NATIONAL TRANSPORTATION SAFETY BOARD Washington, D. C. 20591
Report Type	Aircraft Accident Report July 30, 1971
Distribution Status	Release to Public Unlimited Distribution
Report Class	UNCLASSIFIED
Pg Class	UNCLASSIFIED
Pages	57
Price	P3.00
Keywords	Takeoff, ALS structure, takeoff reference speeds, flap configuration, runway length, preferential runway criteria, NOTAM data, AIRAD data, ATIS information, airport restrictions, communications breakdown, evacuation
Abstract	<p>A Pan American Boeing 747 Struck the Approach Light Structure (ALS) for Runway 19L while taking off from Runway 01R at the San Francisco International Airport. The crew continued the takeoff and, after an inflight inspection for damage, dumped fuel and returned for a landing at San Francisco. Two passengers were injured during the impact with the ALS and ei

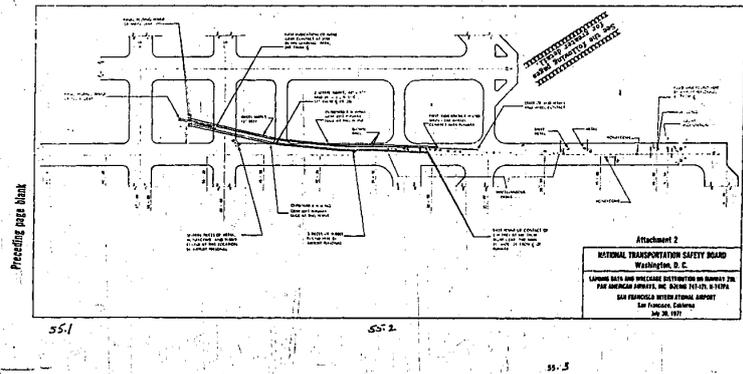
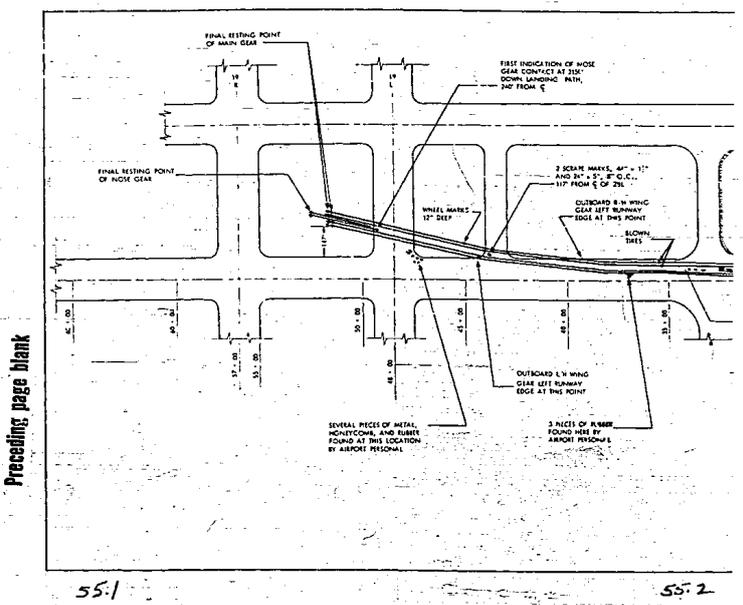
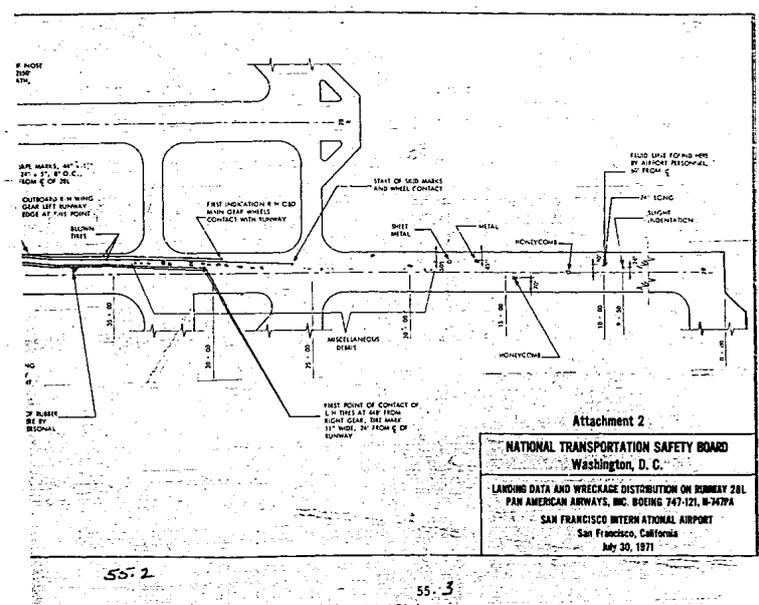
Attachment 2
 NATIONAL TRANSPORTATION SAFETY BOARD
 Washington, D. C.
 LANDING DATA AND WRECKAGE DISTRIBUTION ON RUNWAY 28L
 PAN AMERICAN AIRWAYS, INC. BOEING 747-121, N-747PA
 SAN FRANCISCO INTERNATIONAL AIRPORT
 SAN FRANCISCO, CALIFORNIA
 JULY 20, 1971

After landing, the aircraft veered off the right side of Runway 28L and came to a stop in the unpaved area approximately 5,300 feet from the approach end of the runway.

After the aircraft touched down and was rolling on the runway, the captain tried to configure his engines for reverse thrust. The No. 4 engine was the only one that indicated it had gone into the reverse thrust condition. The captain did not apply power. If he had done so, the aircraft would have swerved violently instead of slowly veering to the right.

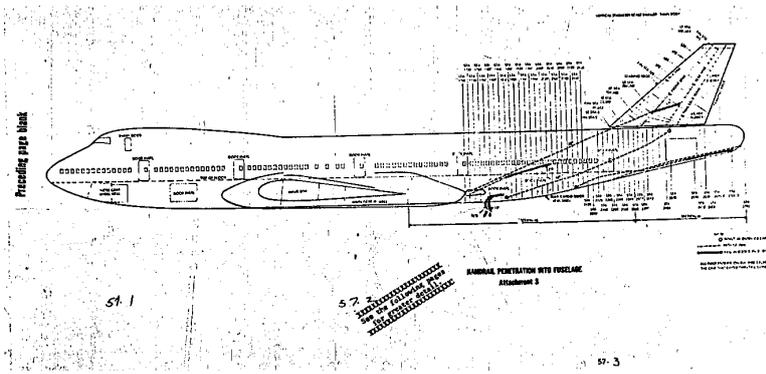
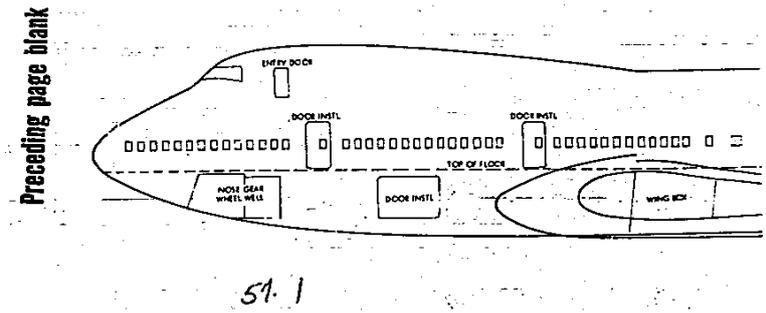
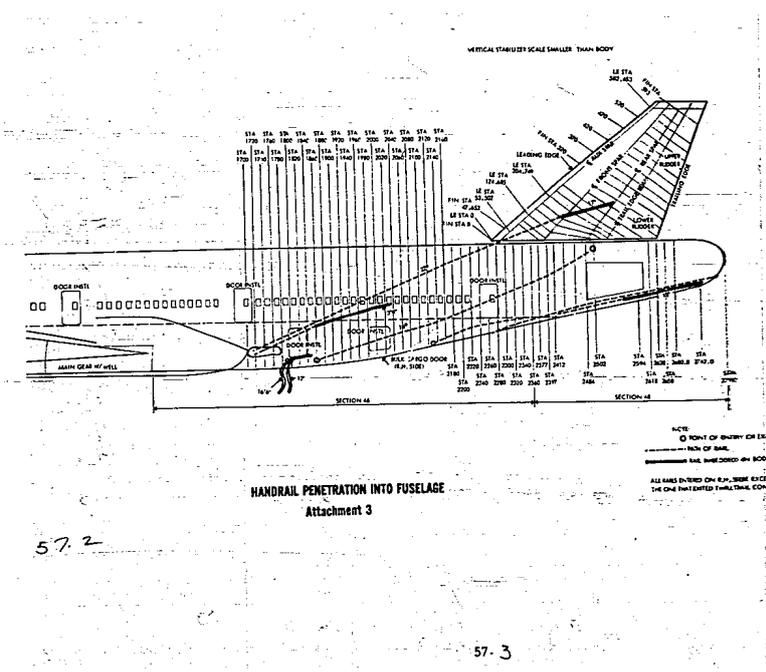
HANDRAIL PENETRATION INTO FUSELAGE Attachment 3

The body landing gears of PA 845 struck the pilings and railings of the approach light pier at the end of the runway during takeoff. Hydraulic systems Nos. 1, 3, and 4 failed immediately thereafter. The right body gear was forced aft and upward into the aft cargo compartment and passenger cabin floor. The left body gear was broken loose and was dangling beneath the aircraft. The bulkhead, to which the body gear was mounted, had failed on both sides of the fuselage. The No. 1 hydraulic system lines for both body gear extend and retract mechanisms were mounted on this bulkhead and were severed during the impact with the ALS structure.

The aircraft's main body gear struck the lights on the first platform of the ALS. The damage to the aircraft and the ALS indicates the aircraft was rotating to a climb attitude as it was passing over the first 300 feet of the ALS. The left body gear struck each of the first 3 light platforms which are mounted to the left side of the walkway facing north, but the fuselage cleared the handrail and service walkway. These strikes by the body gear went progressively deeper into the light platforms and, just past the third platform, the underside of the fuselage came in contact with the handrail and walkway and dragged through approximately 300 feet of the structure. The damage was the result of the aircraft rotation, which effectively lowered the body gear and the aft portion of the fuselage, rather than from a sinking or loss of altitude. The fuselage damage resulted from direct contact with the ALS structure and penetration by pieces of the structure, mainly the steel handrail sections, up through the lower fuselage, cabin and on into the vertical fin. Wood debris and metal pieces also struck the inboard sections of the wing flaps, the horizontal stabilizer, and the elevators. The impact damage failed the Nos. 1, 3, and 4 hydraulic systems. Metal debris that struck the right horizontal stabilizer passed through the stabilizer structure and into the right elevator. This particular missile passed within 4 inches of the No. 2 hydraulic system lines and boost package for the right inboard elevator and was within 4 inches of completely disabling the aircraft flight controls.
